USE OF PRECAST-PRESTRESSED CONCRETE FOR BRIDGE DECKS

July 30, 1975
Revised Dec. 1976
Project: C-36-56N
File: 7-4-14

Joint Highway Research Project

Project No.: C-36-56N

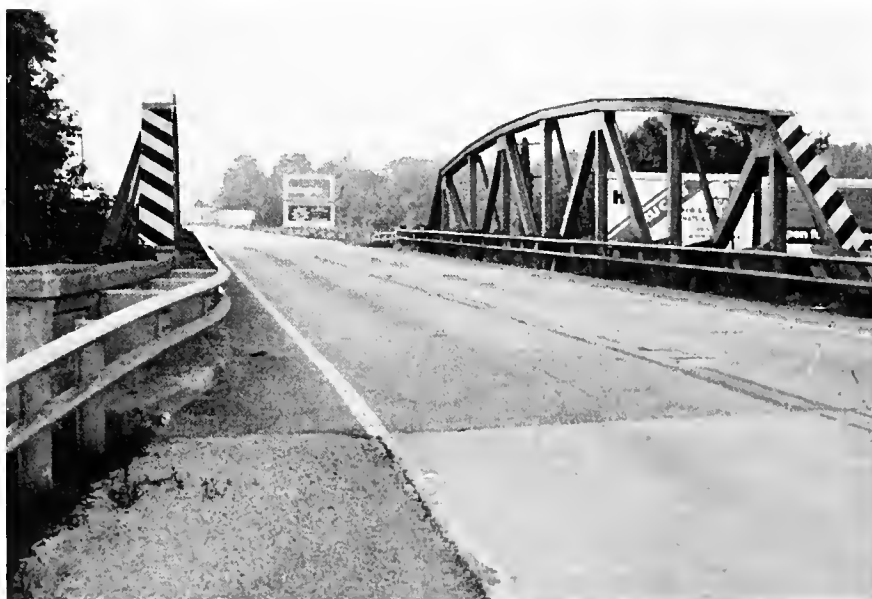
The deck at Bloomington has been in service for five years and for the most part has performed very well. Figure #24 shows the present condition of the Bloomington deck and Figure #25 shows a typical wearing surface joint in the south-bound lane. Most of the problems that have arisen can be traced to poor construction procedures and are not due to the concept used in the design of the precast prestressed deck.

Figure #24. Bloomington Bridge Deck, September, 1974

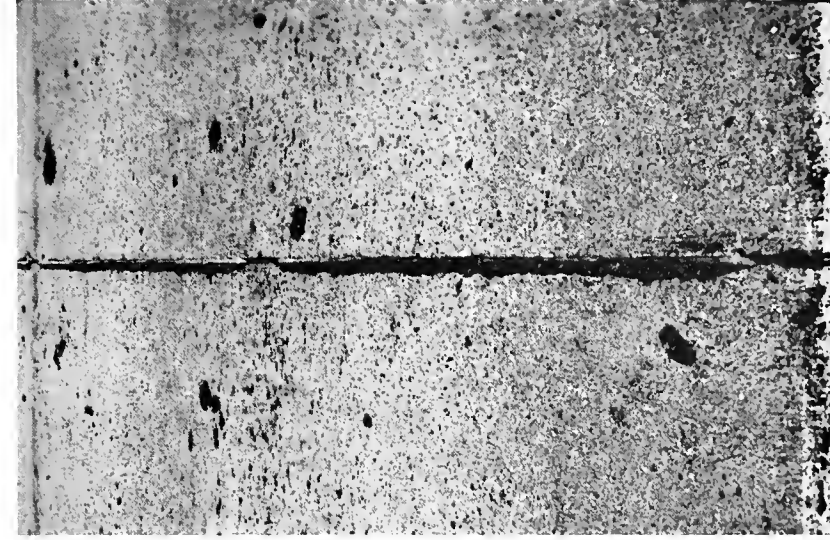
Figure #26. Bloomington Bridge - Repaired Joint in the Southbound Lane. See Figure #27 for Location.

Since all of the sealant repaired and shown on Figure #28 was replaced in late 1970, it is approximately four and one-half years old. DuPont "Imron" was used in all of the repair work and to date has performed satisfactorily, with the exception of minor gravel penetration. A repaired joint can be seen in Figure #26.

of the female joints and after a couple of weeks, traffic pressure worked out the cracked portions of the joint. These joints were repaired by cleaning the joint, forming the joint with Masonite and then filling the broken joint with quick-setting epoxy mortar. The epoxy mortar was allowed to cure and DuPont "Imron" was then used to reseal the joint. One-way traffic was maintained on the bridge during the entire repair operation. One of these repaired joints in the southbound lane can be seen in Figure #26 and its location is shown on Figure #27. All the joints which were repaired at this time are performing satisfactorily.

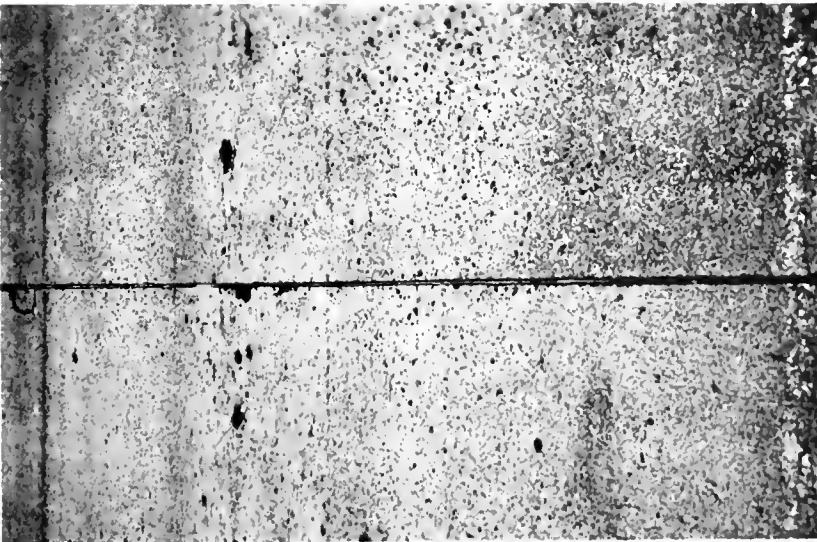
Figure #25. Bloomington Bridge - Typical Wearing Surface Joint in the Southbound Lane. See Figure #27 for Location.

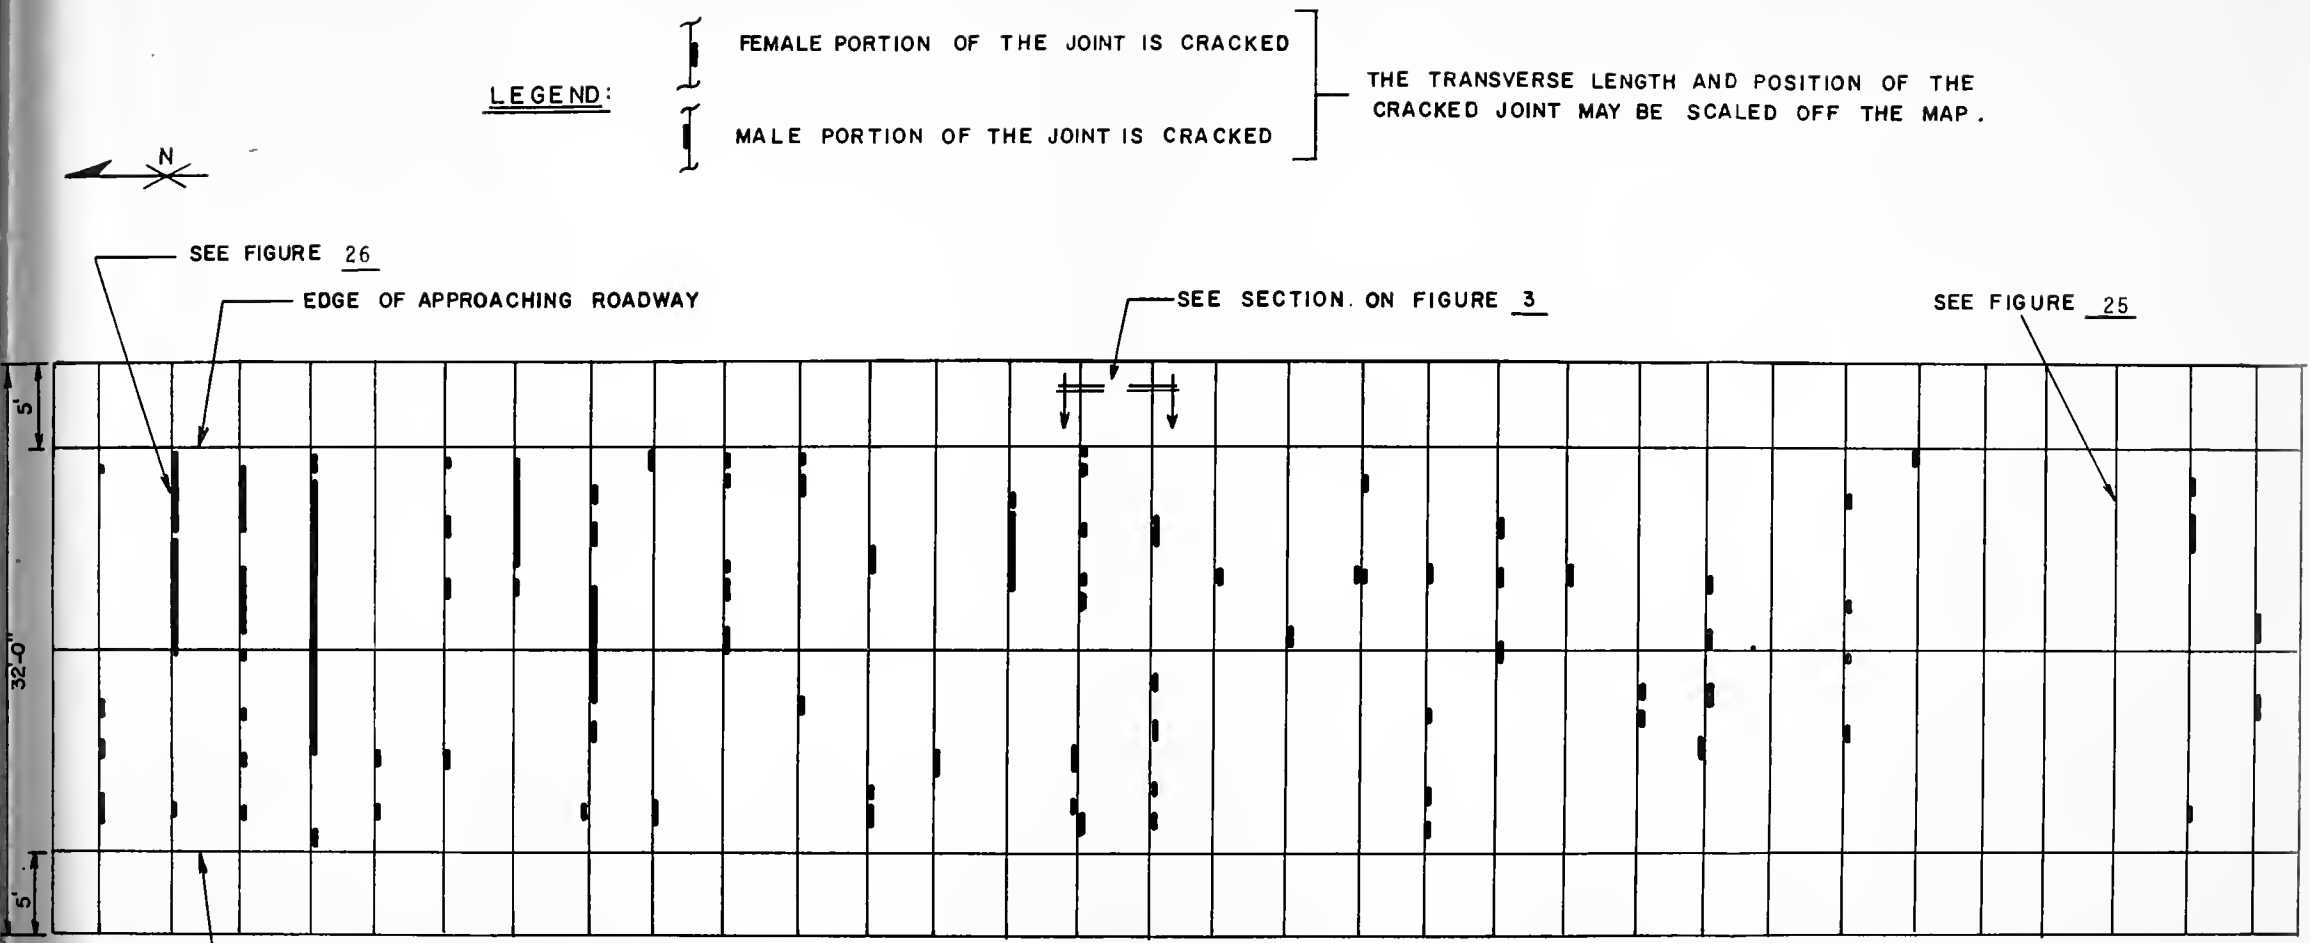
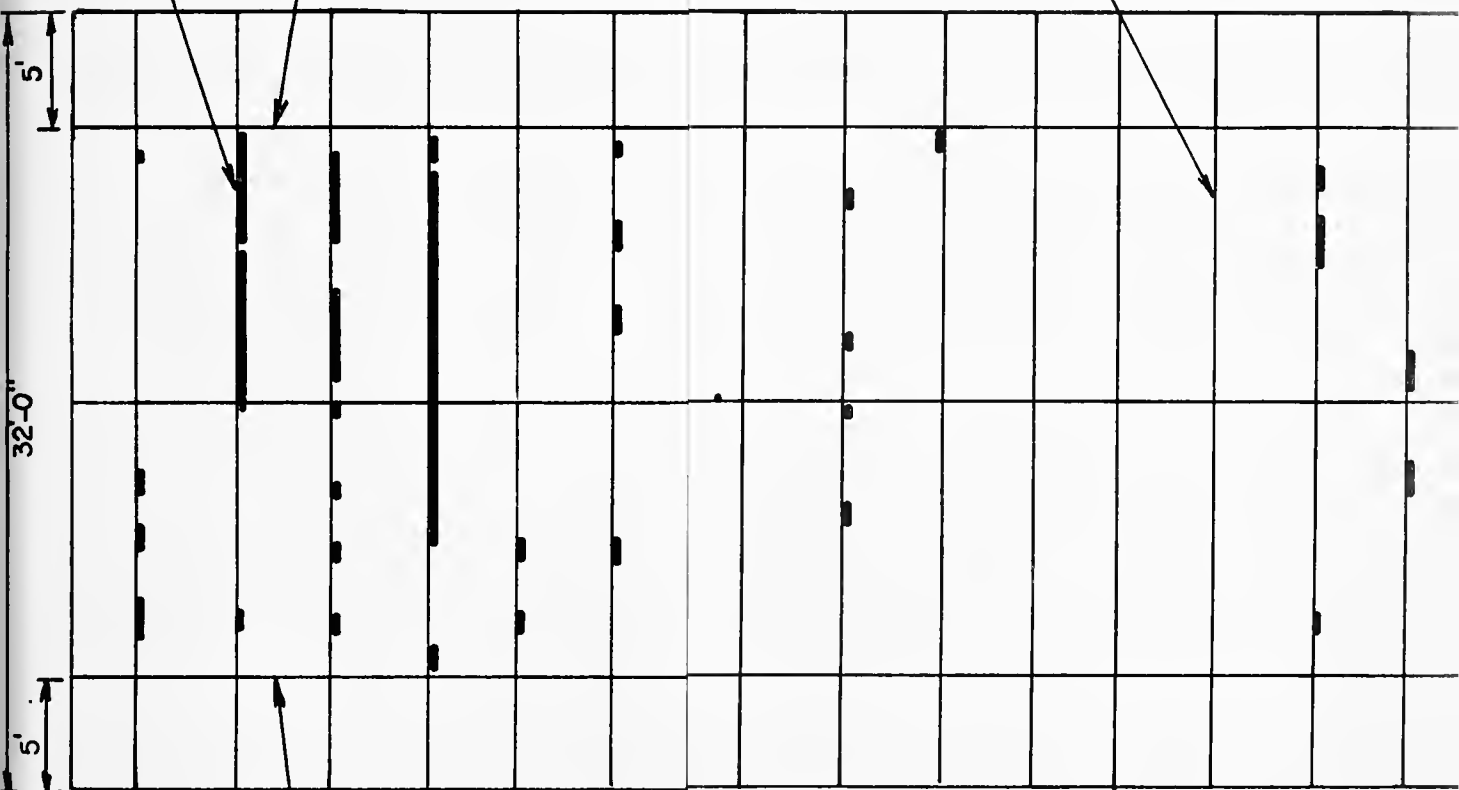
FIGURE NO. 27

Figure #27 is a map of all the joints which have cracked or spalled since the bridge was opened to traffic. All of the distressed areas lay in the traffic lanes which tends to indicate that traffic wear is the major cause of the joint cracking or spalling. The two main reasons why the traffic is causing the cracked joints are variations in slab elevations and the use of snow removal equipment. The elevation between slabs vary as much as 1/4" and under repeated wheel load applications, the raised lip of the high slab will either ravel or crack. Usually if the raised edge is the female side of the joint, the female edge will crack and if the raised edge is the male portion it will ravel. The only solution to this problem would be making sure that the slabs were leveled during erection. The other major cause of the cracked joints is the impact load imposed on the slab joints by the blades from the snow removal trucks. Two solutions to this problem might be: (1) using more de-icing chemicals and not using the snow plow blade on the bridge or (2) in the future use a different joint configuration which would eliminate the weak edge inherent in the female portion of the joint.

MAP OF SPALLED OR CRACKED JOINTS

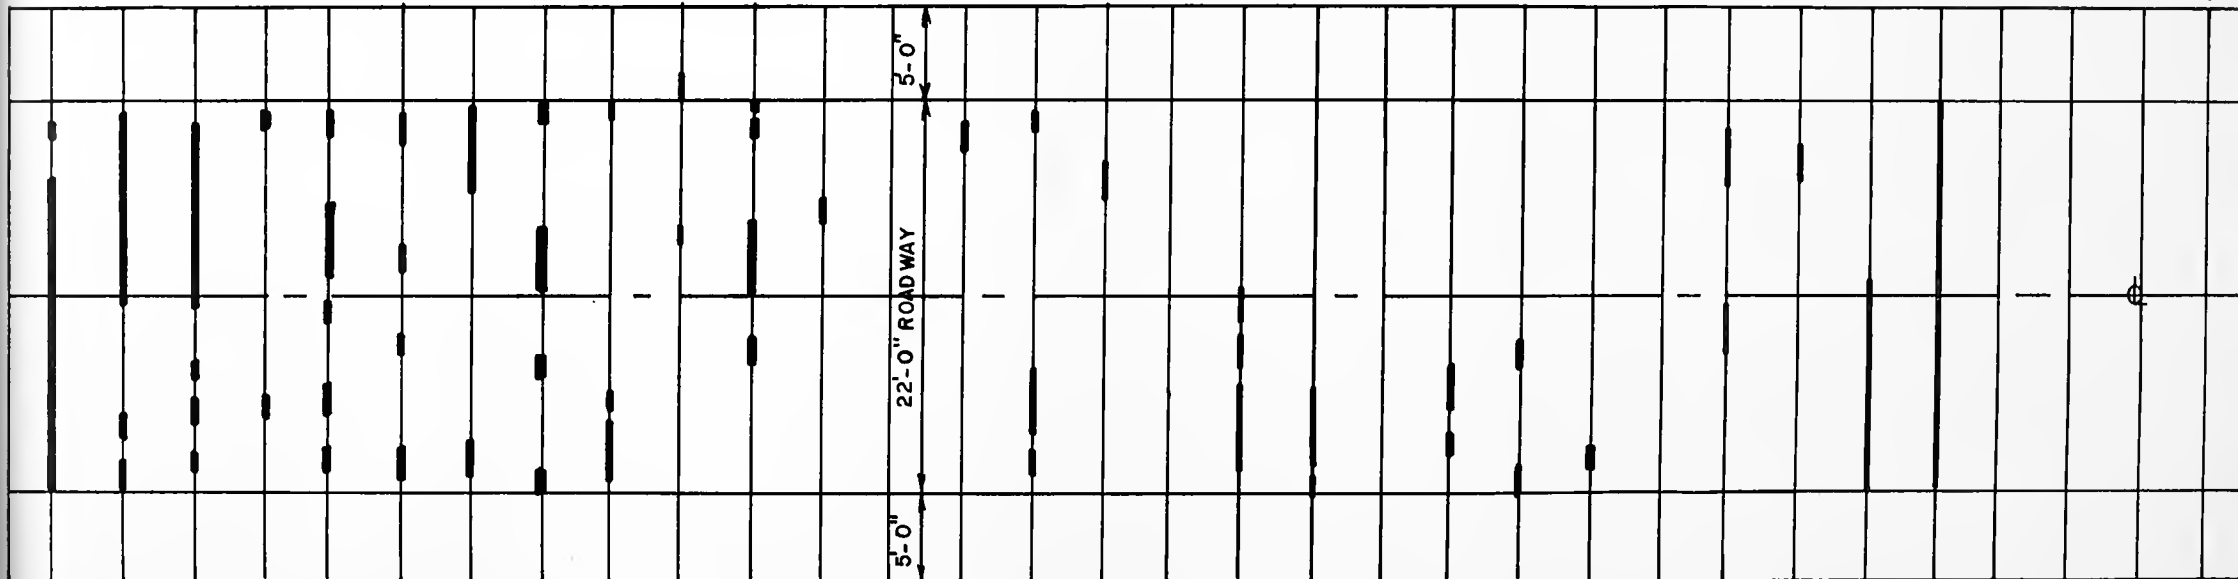
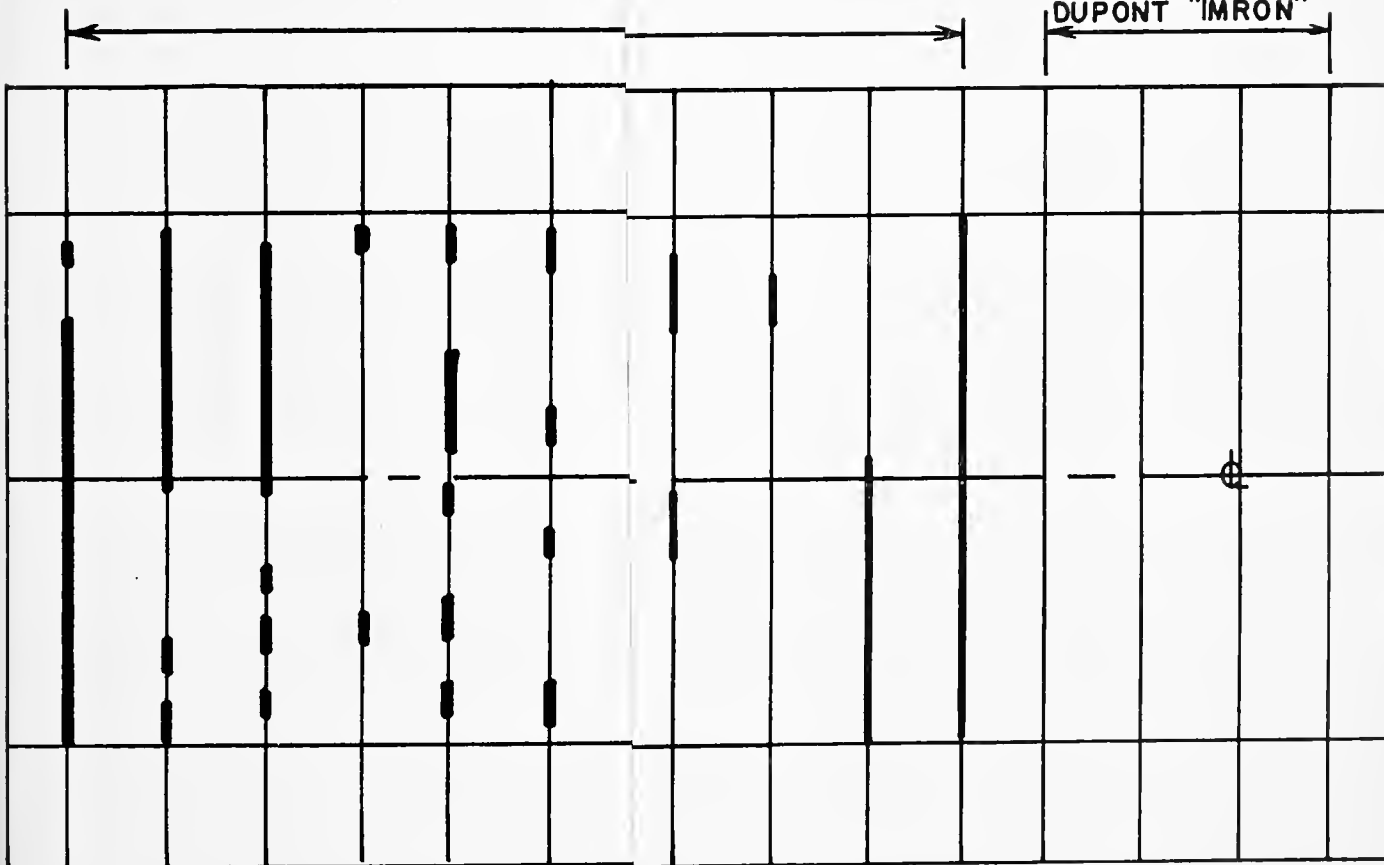
FIGURE NO. 28

will usually work out of the joint under traffic loads. Figure #28 is a map of the areas where the joint sealant has been replaced and shows which areas originally were sealed with the liquid polyurethane sealant and which joints were sealed with DuPont "Imron". In addition to the reasons stated above, the joint sealant also had to be replaced for the following reasons: (1) joint material itself, (2) application techniques which were mentioned earlier and (3) gravel punching the sealant into the joint.

During the inspection of the precast deck in June, 1974 it was noted that nearly all of the joints leaked during a rain. The exact position of the leaks could not be located since the water entering the joint can travel along the inside of the joint before appearing at the bottom side. These leaks were mainly caused by the liquid polyurethane sealant which was initially poured into the majority of the joints. As was described earlier, air became entrapped in the liquid sealant as it was being poured into the joint. The entrapped air formed bubbles which expanded when heated and pushed the sealant above the surface of the deck. These bubbles were subsequently worn away by the traffic, leaving honeycombed voids which would readily pass water. Since this condition occurred in the majority of the joints, it was decided at the time that it would not be feasible to replace all of this sealant.

PLAN VIEW OF THE BLOOMINGTON BRIDGE DECK
MAP OF THE AREAS WHERE THE JOINT SEALANT
HAS BEEN REPLACED

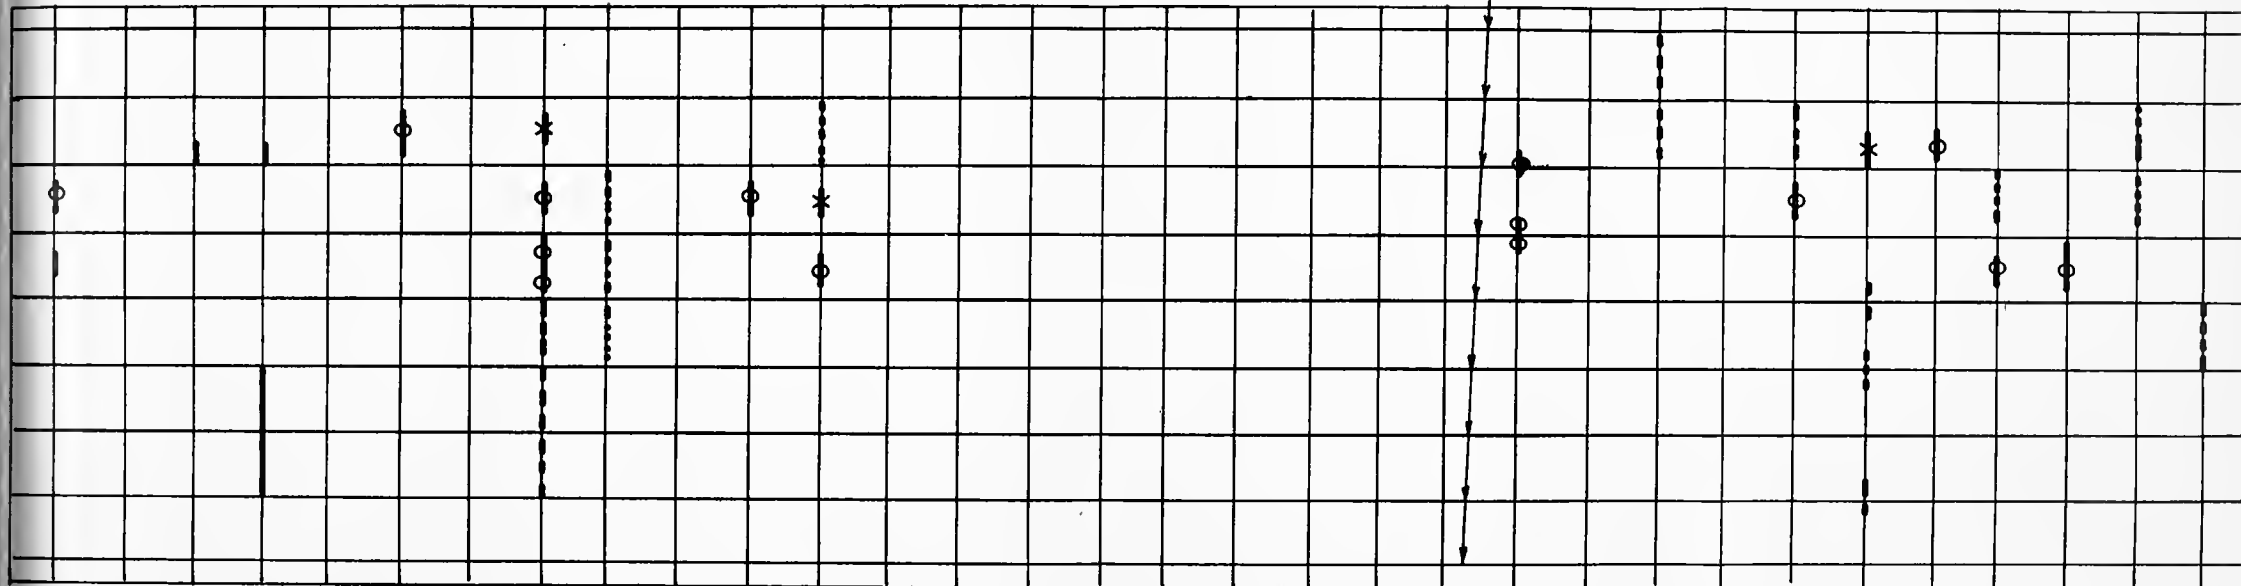
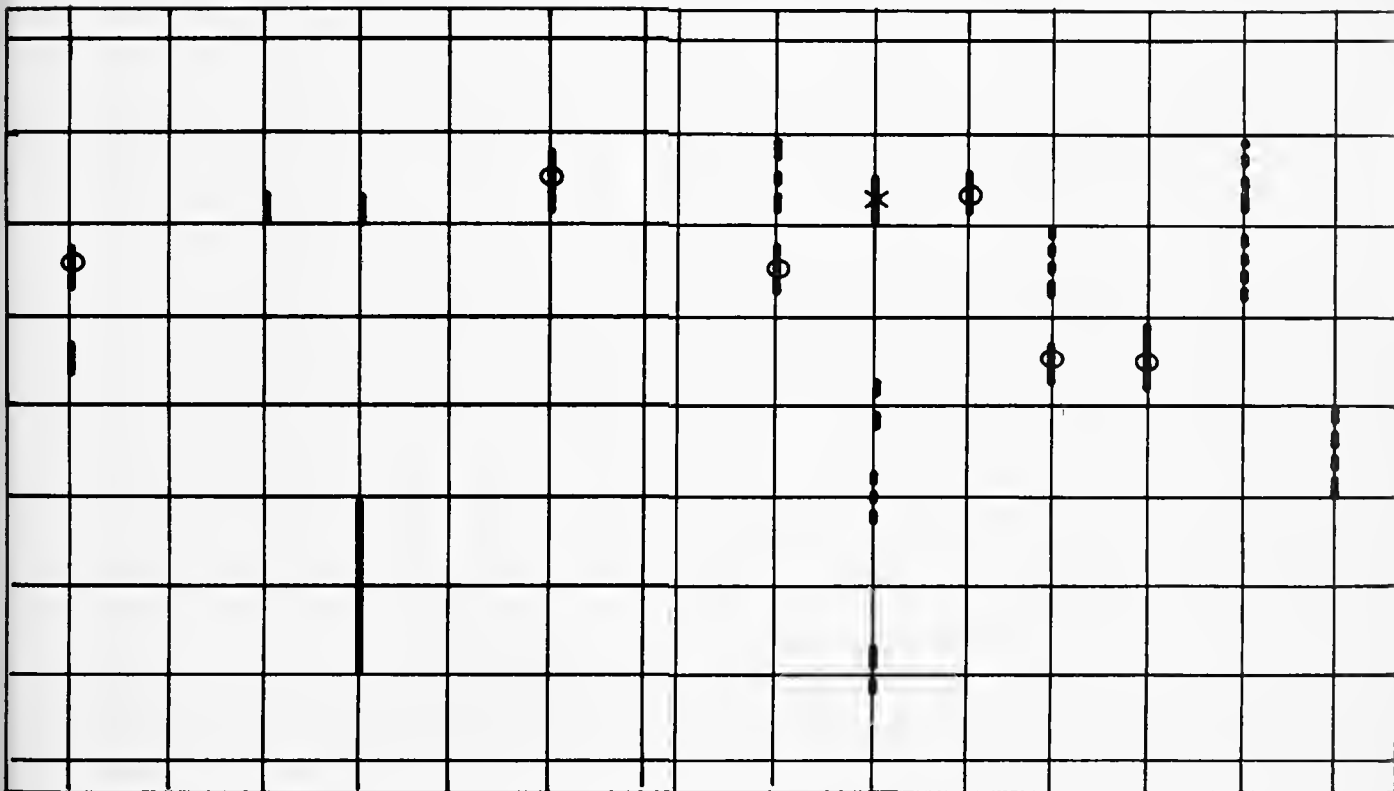
FIGURE NO. 29

Figure #29 shows the areas under the deck where the neoprene sheet has worked down out of the joints. The neoprene sheet was used to minimize stress concentrations between the joints due to minor surface irregularities. The compressive stress in the neoprene was relatively high in the areas where it has worked out of the joints. This high stress was due to a major irregularity in the surface of the joint which was in turn caused by warping of the forms where the slabs were poured. In order to relieve this high stress, the neoprene works out the joint under the repeated traffic load.

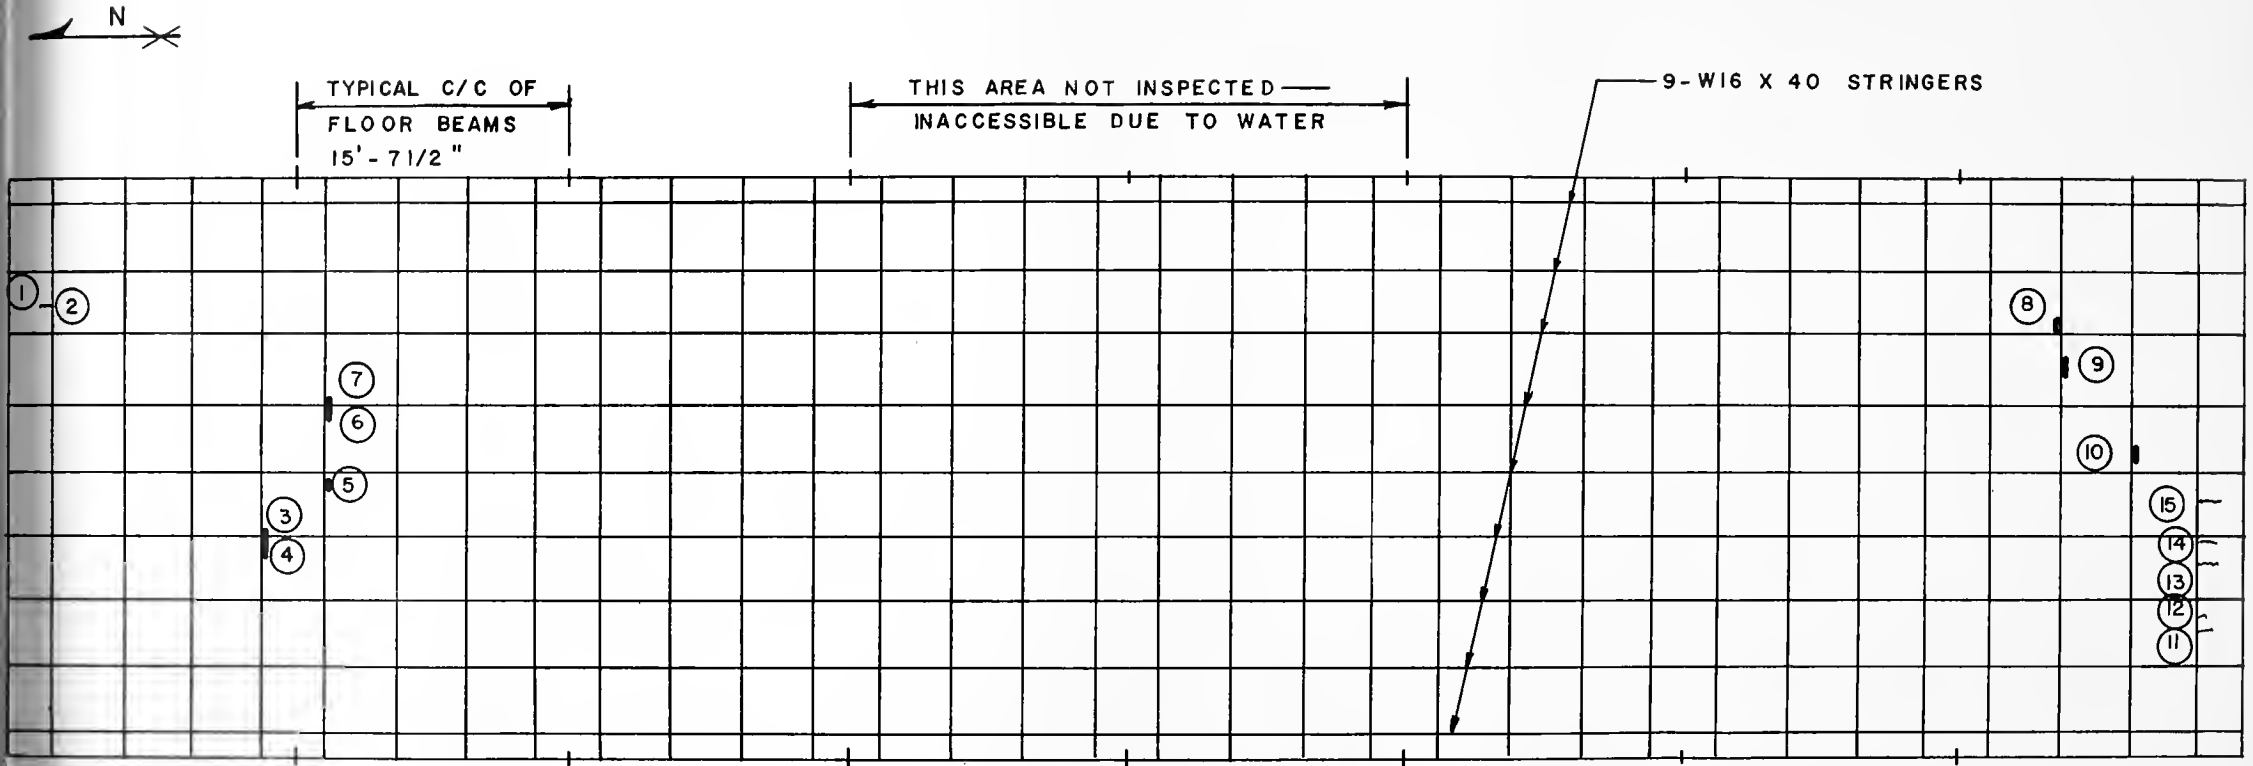
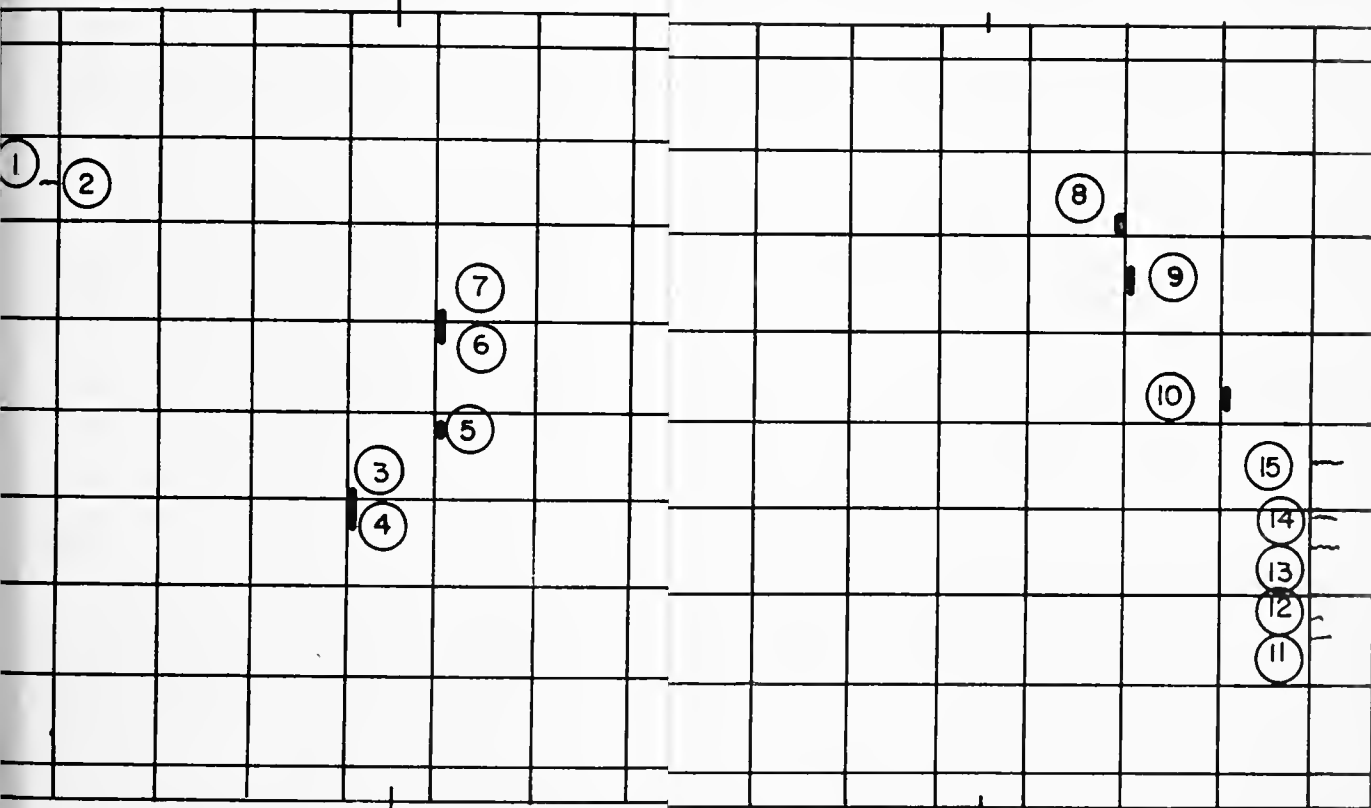
FIGURE NO. 30

Figure #30 is a map of the other distressed areas on the underside of the slabs and Table 2 describes the condition of each of the numbered areas on the map. The probable cause for the broken clips and bolt in area ① was the initial lack of bearing between the slab and the stringer. This lack of bearing was noticed after the bridge was opened to traffic and shims were immediately driven between the slab stringer and precast slab, but the traffic load kept working the shims back out of the void (See Figure #31).

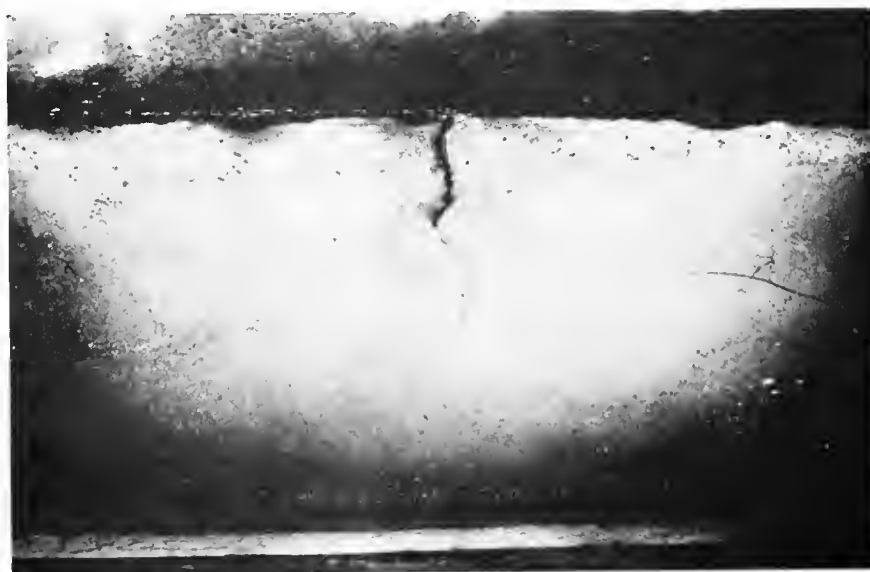
| ② 8" longitudinal surface crack | See Figure #32 |

Figure #32. Area ② - 8" longitudinal surface crack (See Figure #30 and Table 2)

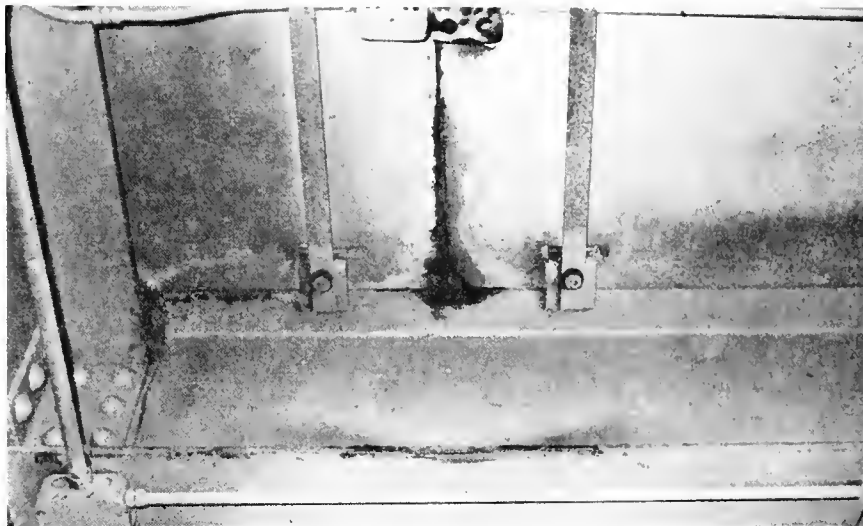
Figure #33. Area ⑤ - (Typical of Areas 3 thru 7) Cracked female joint at the stringer bearing point. (See Figure #30 and Table 2).

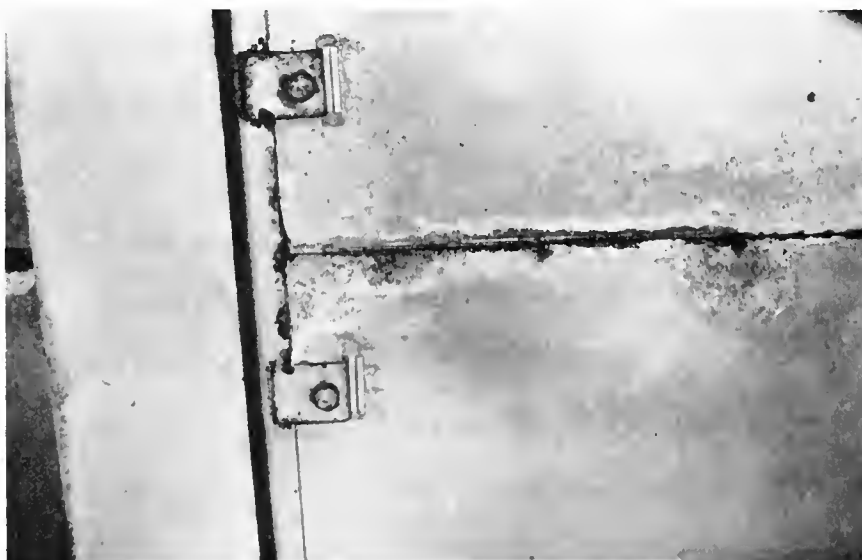
| ⑧ Spalled male portion of the joint

Figure #34. Area ⑧ - Spalled male portion of the joint--2"x2"x1/4" deep (See Figure #30 and Table 2).

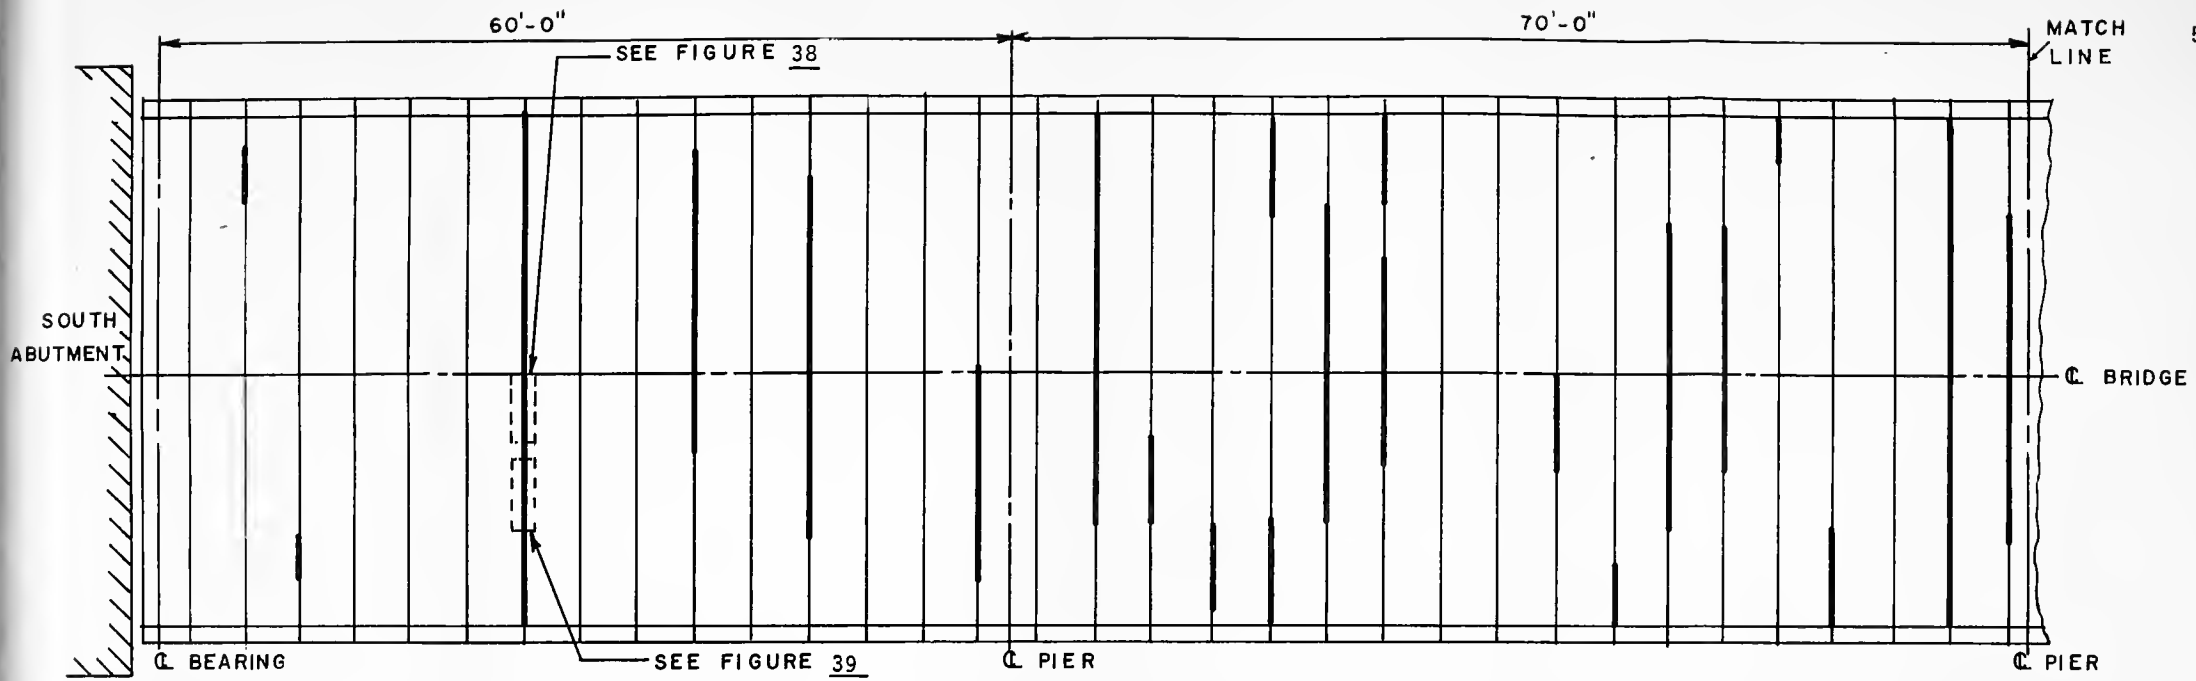
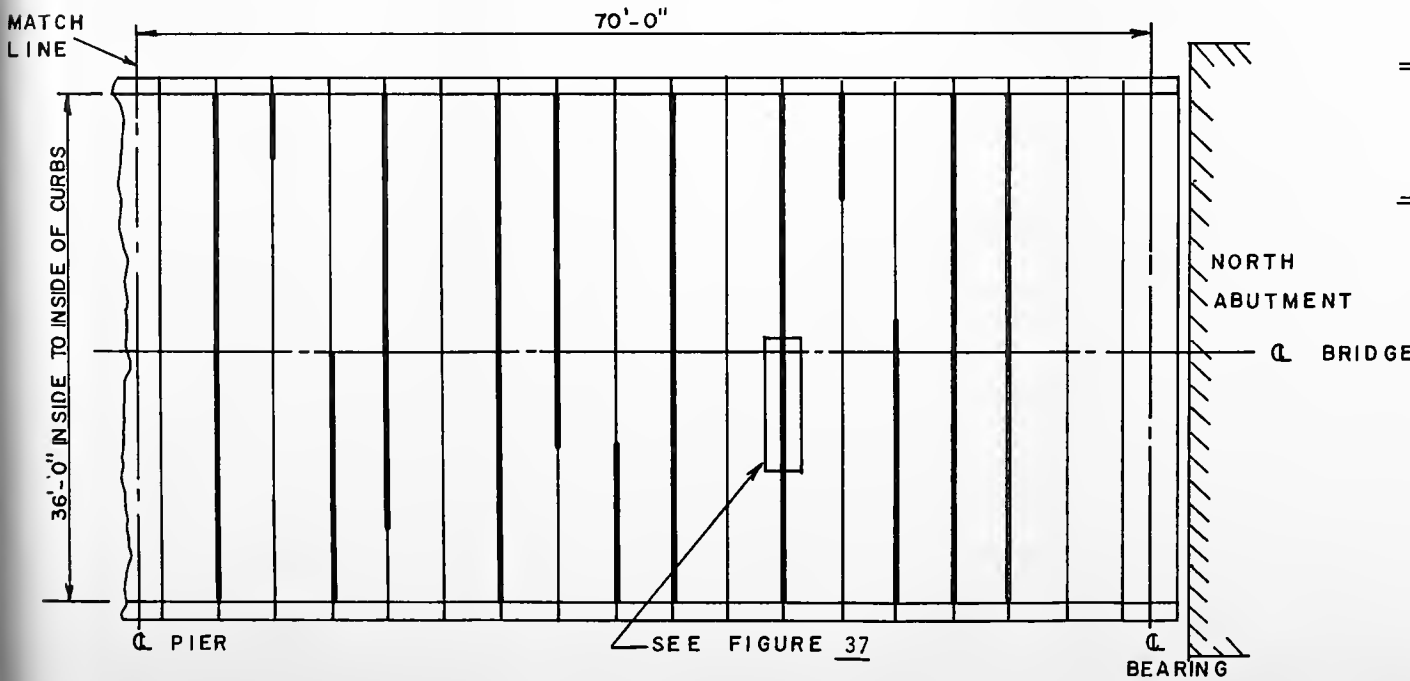
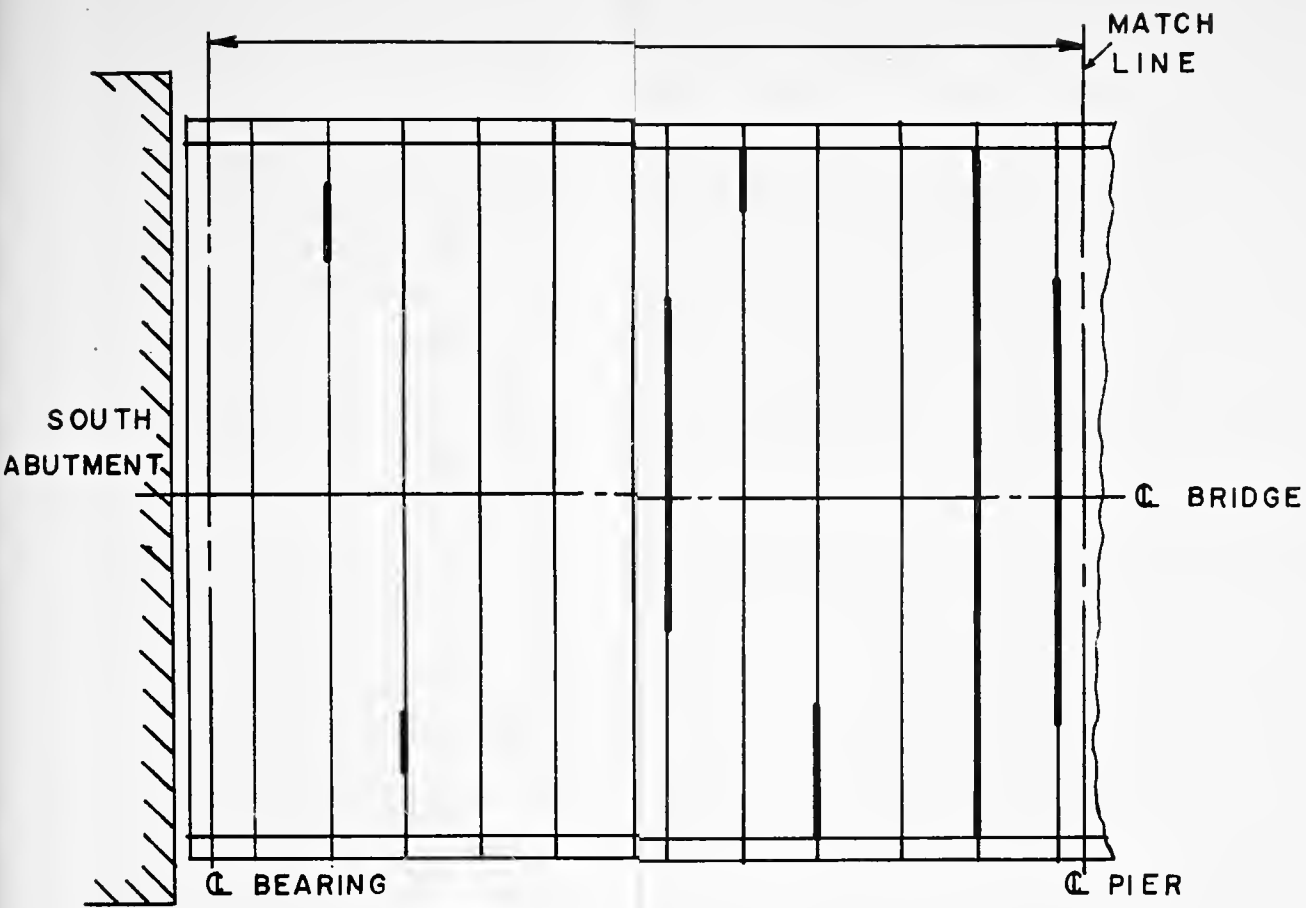
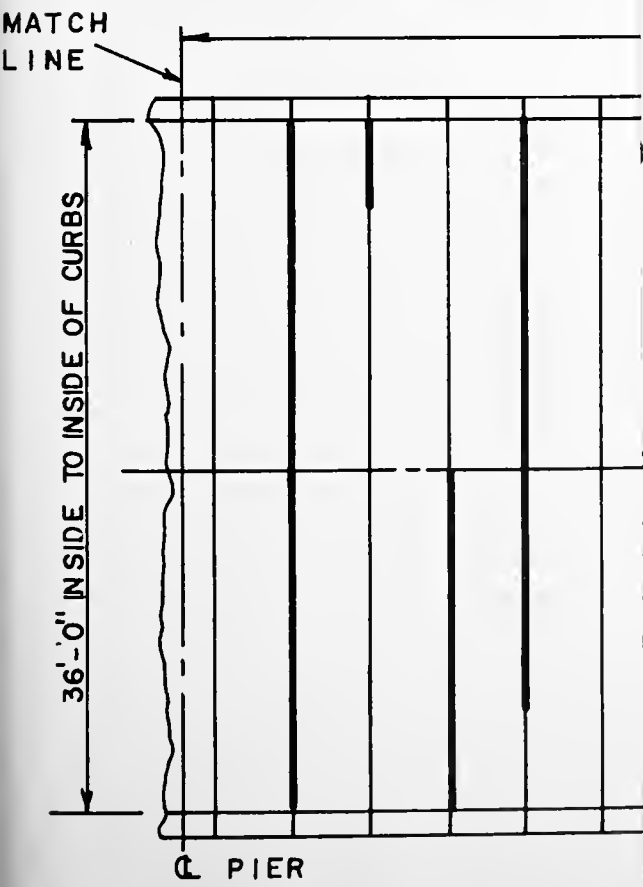
FIGURE NO. 36
PLAN VIEW OF THE KNIGHTSTOWN BRIDGE
MAP SHOWING AREAS WHERE THE WIDTH AT
THE TOP OF THE JOINT IS LESS
THAN 1/8 INCH.

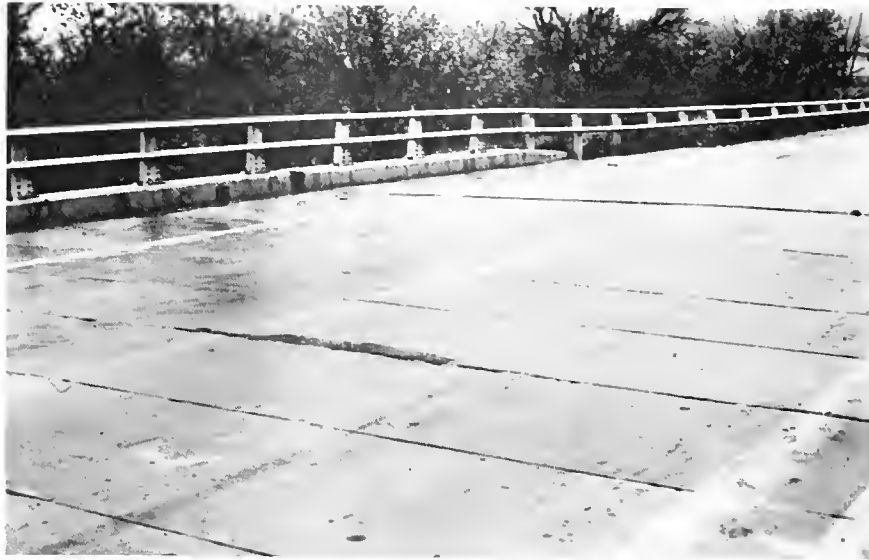
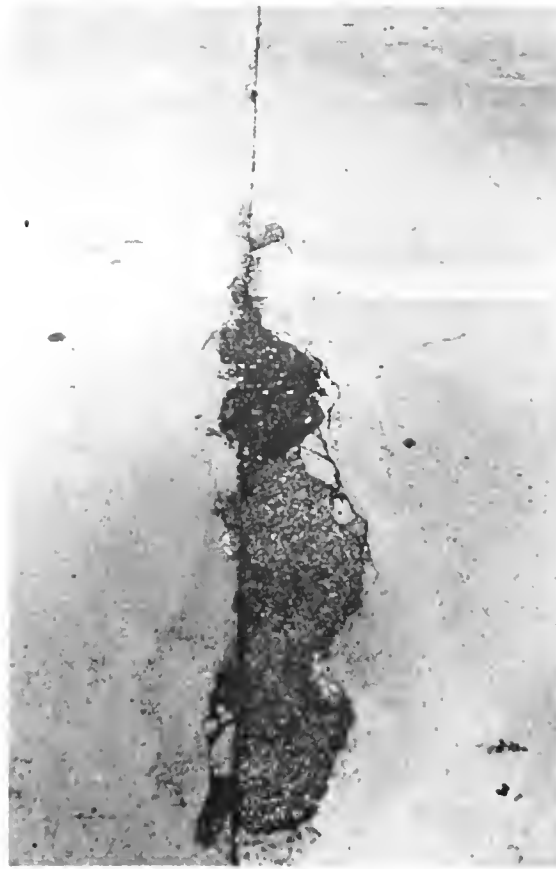
Figure 37. Knightstown Bridge - Progressive Failure of the Male Portion of the Joint. See Figure #36 for Location.

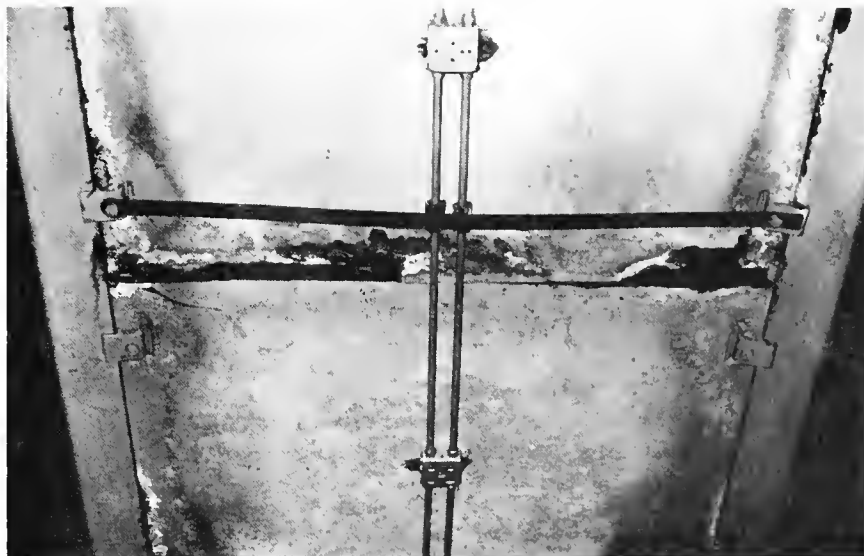
The only other problem observed at Knightstown was that concrete patches applied in the precastor's yard deteriorated after about one year. The photographs in Figures #38 and 39 show patched female joints on the underside of the slab where the patch has deteriorated or has fallen out of the joint. Also there are only a few places where the neoprene has started to work out of the joint.

Figure #38. Knightstown Bridge - A Patch Applied in the Precaster's Yard Which Has Failed. See Figure #36 for Location.

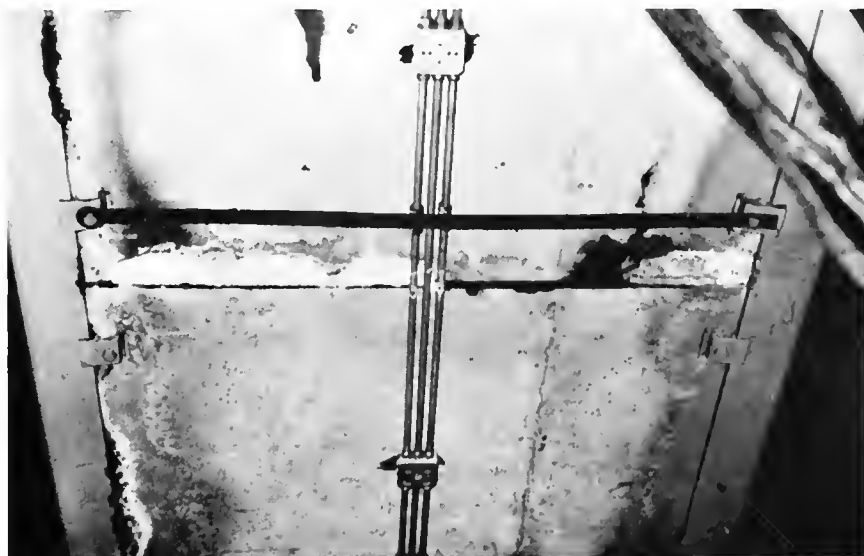
Figure #39. Knightstown Bridge - A Patch Applied in the Precaster's Yard Which Has Failed. See Figure #36 for Location.
